TOWN OF CAMPBELL
RECONNAISSANCE LEVEL SURVEY

Johnson-Schmidt & Associates, Architects

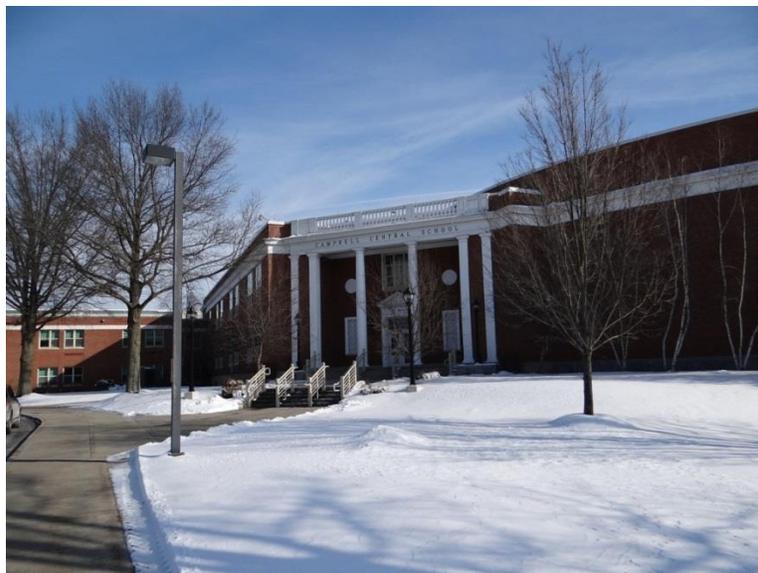
The Campbell-Savona Jr. /Sr. High School was designed by Carl C. Ade, an architect from Rochester, NY. The front façade, which features Greek Revival detailing, has remained untouched. Multiple additions have been added to the original building, such as the northwest addition erected in the 1970s as the grade school wing. Other additions to the rear of the building have been made more recently.

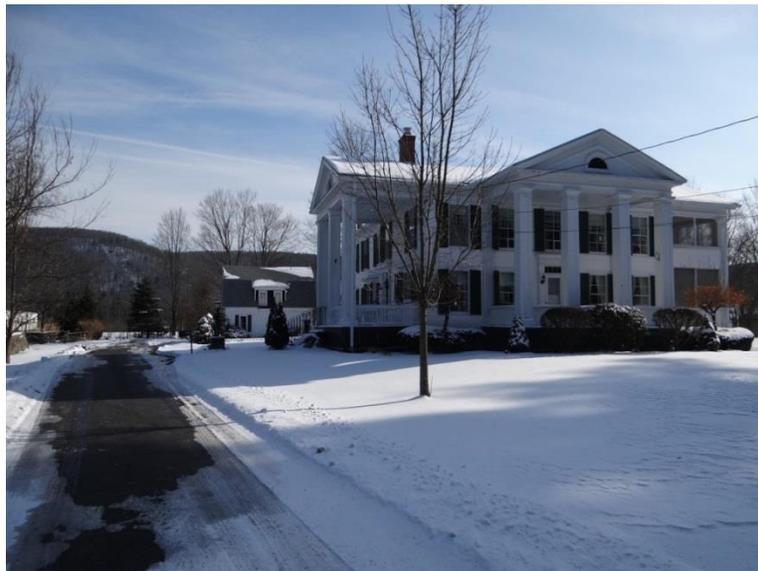
The property that this Greek Revival residence sits on was purchased by the Horton family in 1828, and the home was constructed soon after. The family had gained their wealth through farming. The home retains a majority of the original and historic materials and features and is the most ornamental Greek Revival style homes in the Village of Campbell. Overall, the home is significant to the Village of Campbell's intact historic inventory or varying architectural styles of the 19th and 20th centuries.

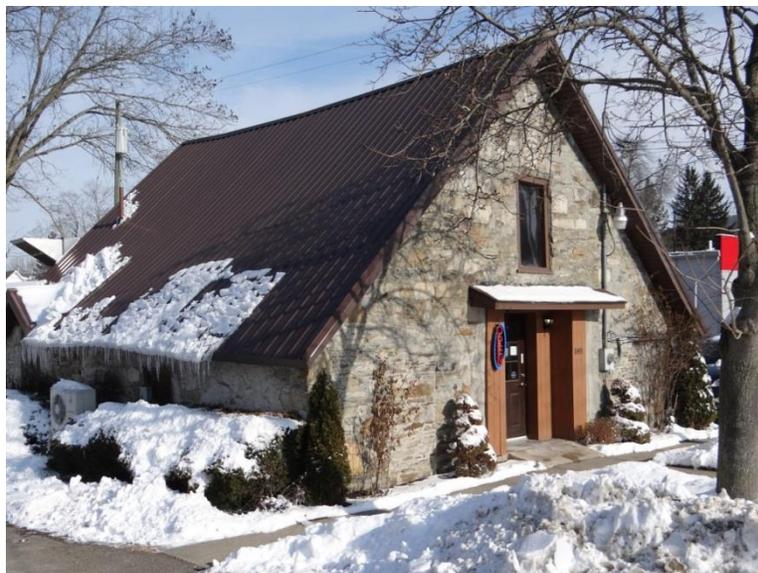
The Stonehouse Café building was originally constructed ca. 1880s by George W. Jaynes for his blacksmith shop. Jaynes specialized in making spikes for the Lackawanna Railroad while it was being built in the area. This is the only building constructed completely of stone in Campbell, making it an important and unique example of historic architecture in the Dutch Colonial style still in existence.

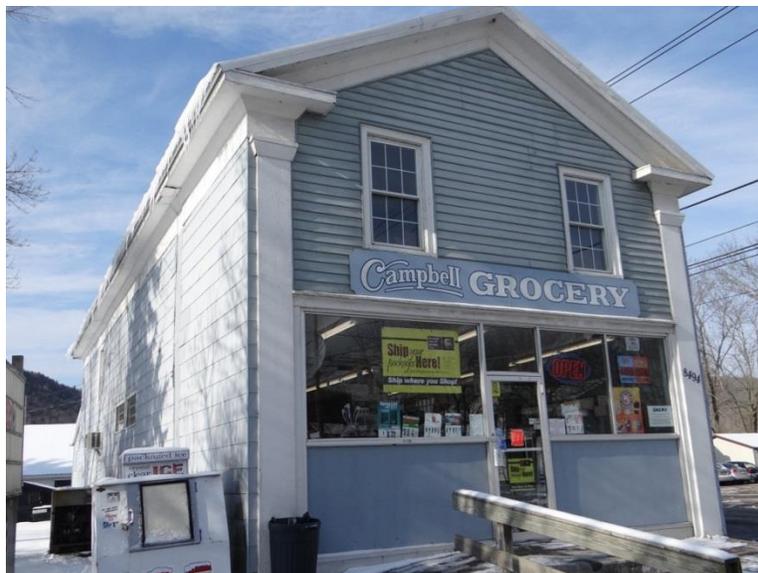
This is a two-story, two-bay, commercial building with Greek Revival detailing and a front-gable roof. The storefront has been altered from the original and features a central entrance, tall flat-panel bulkheads and metal framed storefront windows above. To each side of the storefront is a simple Doric pilaster. The second-story of the front façade has vinyl siding and two six-over-six replacement windows within the original wood frames. The side elevations are clad with wide wood clapboard and have a simple frieze detail, which wraps to the front façade pediment ornamentation.

The Campbell Grocery, originally known as Sutton’s Store, was constructed in 1846 as a lumber company. The building retains some historic materials and has not had any additions made to it. The store is significant as an example of Greek Revival commercial architecture remaining in the historic commercial district of the Village of Campbell.

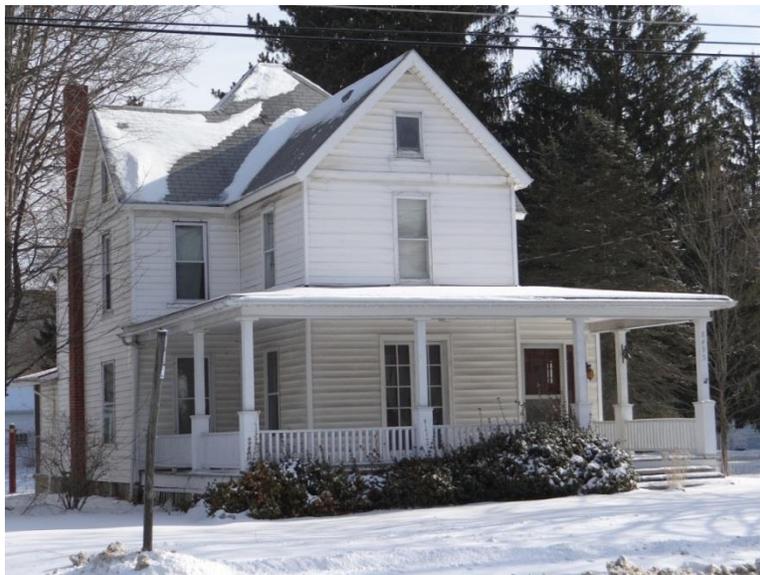
This is a two and one-half story, Queen Anne-style home. The porch stretches the width of the home and wraps partially around the side elevations and retains the original tongue-and-groove wood decking. It features simple rectangular posts, columns, and railings. The front protrusion features two ten-lite French-style doors. All other first and second-story windows are one-over-one metal replacements. The roof is clad with asphalt shingles.

The Aull house is historically significant as an intact example of the Queen Anne style in a potential historic district. The Aull's, who were the original owners, owned a hydro-electric plant and this house became the first house in Campbell with outside lights. Eventually, the Aull's hydro-electric plant became a part of NYSEG. Overall, the home is significant to the Village of Campbell's intact historic inventory or varying architectural styles of the 19th and 20th centuries.

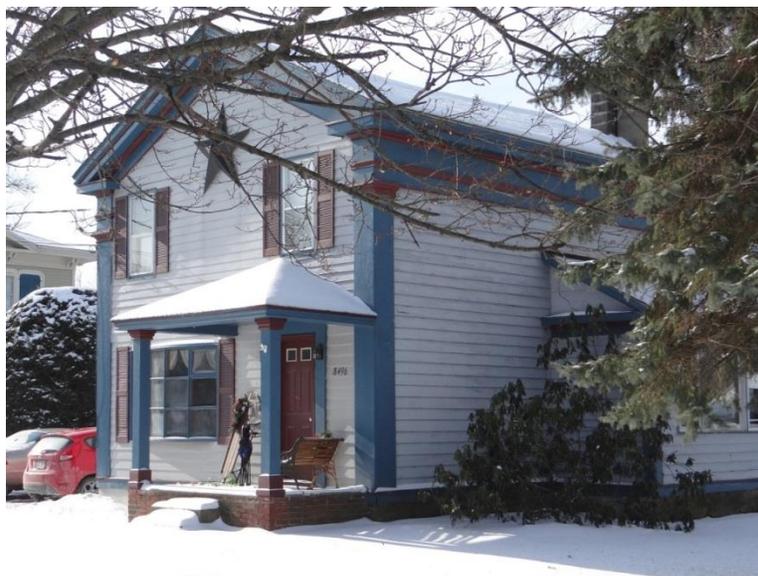
This is a two-story, two-bay, Greek Revival-style residence. The first-story, front façade features a twelve-lite bay window and simple entrance. A brick porch on the northern side of the front façade is supported by two simple vernacular Doric-style columns and has a hipped roof. The second-story features two one-over-one replacement windows. At the corners of the front façade and side elevations are Doric inspired pilasters that wrap the building's corners and above is a decorative frieze and trim that wraps to the front façade's pediment ornamentation. This building's design is similar to that of the Campbell Grocery to the northwest.

This home is significant as an intact example of Greek Revival architecture. The building was originally constructed for the Bemis-McKay store, but has since been converted to a residential home. Overall, many of the exterior detailing elements have been maintained. This building was constructed in the same style as the Campbell Grocery next door. Overall, the home is significant to the Village of Campbell's intact historic inventory or varying architectural styles of the 19th and 20th centuries.

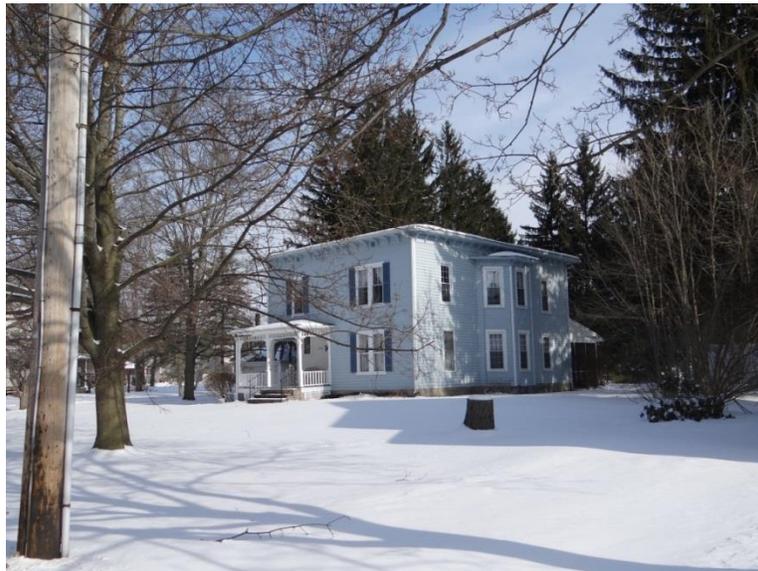
The Weale house is historically significant as an example of Italianate residential architecture from the mid-1800s. Although some modifications have been made, the home retains many of its historic features and materials. The home was originally constructed for the daughter of the Platt's, who owned Platt's General Store, which also still exists in the Village. Overall, the home is significant to the Village of Campbell's intact historic inventory or varying architectural styles of the 19th and 20th centuries.

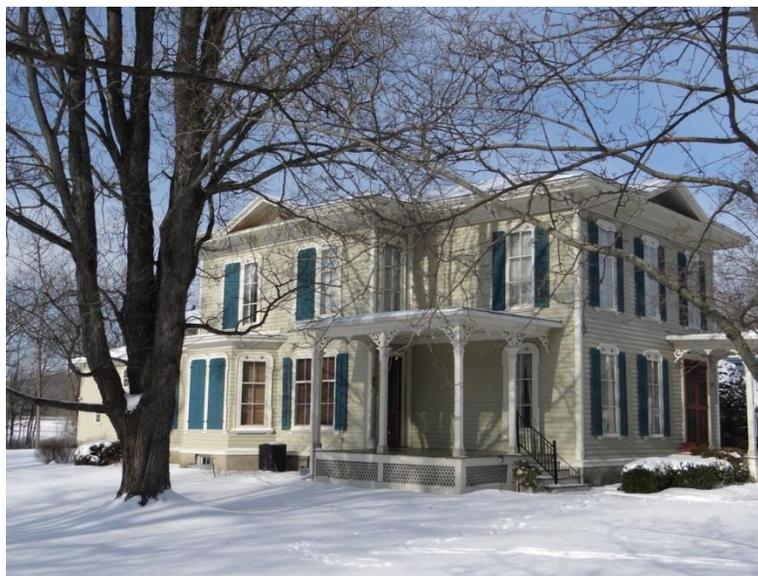
This home is historically significant as an intact example of Italianate residential architecture from the mid-1800s. A majority of the historic features and materials have been retained and were well maintained over time. The property also retains the original two-story carriage house. Throughout the years, the home was typically owned by a local prominent doctor. Overall, the home is significant to the Village of Campbell's intact historic inventory or varying architectural styles of the 19th and 20th centuries.

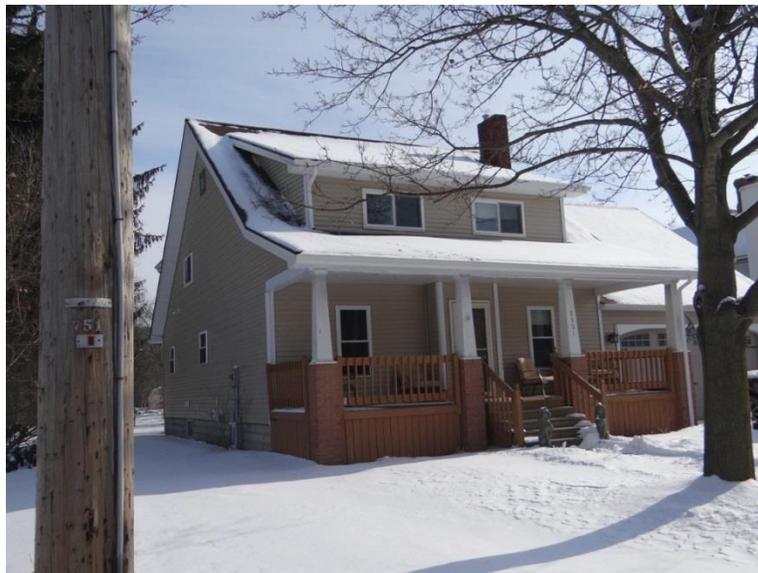
This is a one and one-half-story, Craftsman-style residence with a side-gable roof. A porch spans the front façade of the home and features tapered wood columns atop brick piers. The wood porch decking and railing are not originals. Windows are one-over-one vinyl windows. A wide dormer with shed roof spans almost the width of the building. The dormer features two sliding replacement windows. A chimney rises along the southeast end of the home. A two-car garage is attached to the southeast side of the home.

This home is significant as one of the few examples of Craftsman-style residential architecture. There have been some major additions and alterations to the home. Overall, the home is significant to the Village of Campbell's intact historic inventory or varying architectural styles of the 19th and 20th centuries.

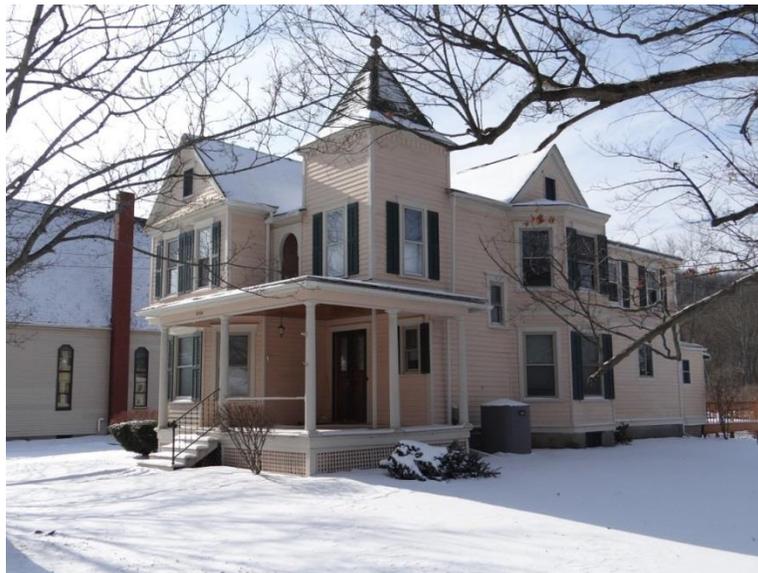
This is a two-story, Queen Anne-style residence. The home is clad in wood clapboard siding. The front façade of the home features one-over-one replacement windows and historic wood trim and frames. The main entrance on the front façade is comprised of two narrow, half-lite wood doors. The porch features fluted support columns and the historic tongue-and-groove wood decking. The northwest side of the front façade is a two-story tower with a steep-pitched hip-style roof. The roofing is asphalt shingles.

This home is historically significant as an intact example of the Queen Anne style in the Village of Campbell. It is one of the more prominent historic homes that retains much of its historic features and materials. Overall, the home is significant to the Village of Campbell's intact historic inventory or varying architectural styles of the 19th and 20th centuries.

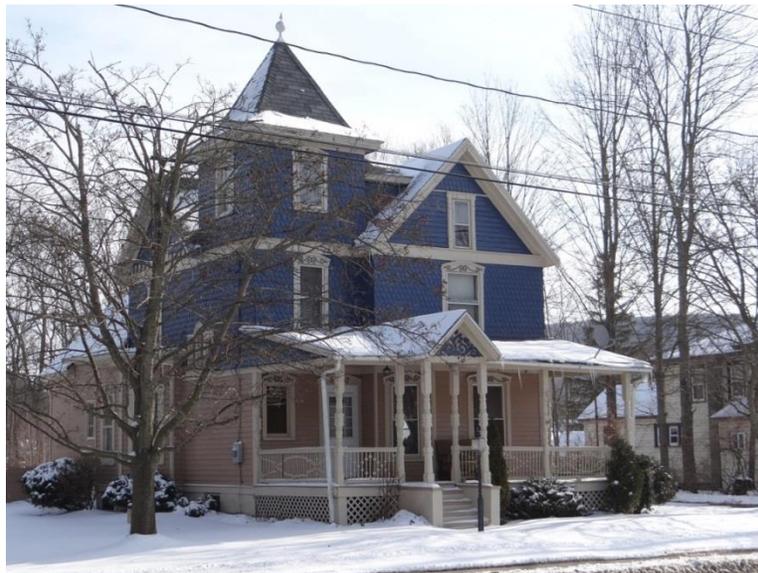
This home is historically significant as an intact example of the Queen Anne style in the Village of Campbell. The home retains a high level of historic detailing, materials, and features and is in overall excellent condition. Overall, the home is significant to the Village of Campbell's intact historic inventory or varying architectural styles of the 19th and 20th centuries.

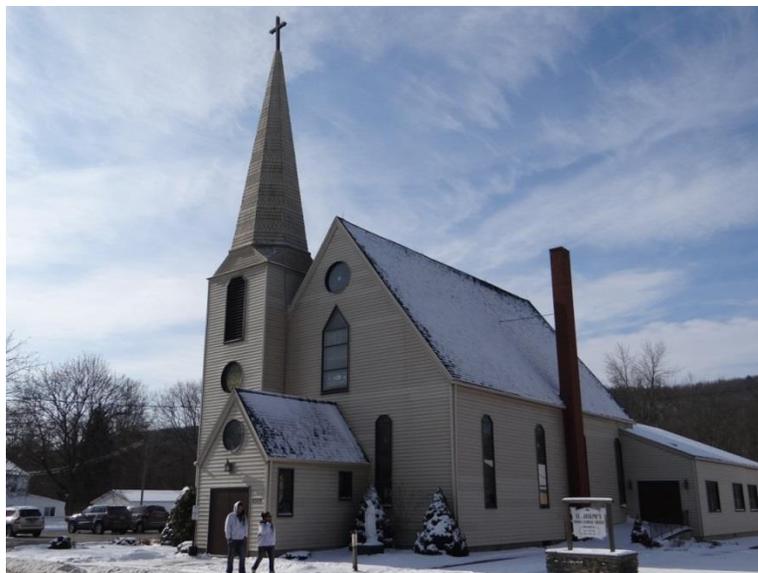
This religious building has elements of both Italianate and Queen Anne detailing. The building is clad in vinyl siding and retains some historic stained-glass windows. The southeast corner of the building features a tall tower with a steeply-pitched decorative shingle roof. A brick chimney rises at the center of the northwest elevation. A large addition is at the rear of the building.

This church is significant as a religious structure from the mid-1800s. Founded by Irish immigrants who worked in the mills across the river, this church has remained in its original location. A rear addition was added as space was needed; however, the overall significance of the historic church has remained intact.

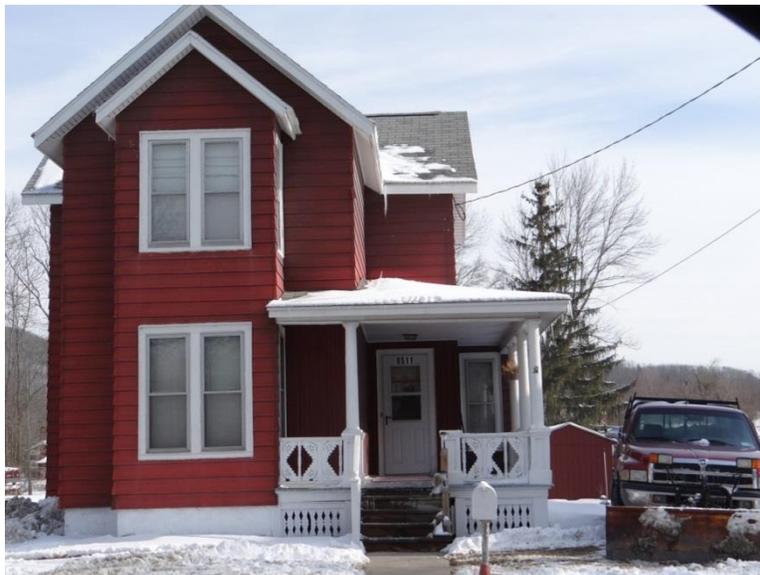
This home is historically significant as an intact example of the Queen Anne style within the Village of Campbell. The home has been well maintained with a majority of the original materials remaining. Overall, the home is significant to the Village of Campbell's intact historic inventory or varying architectural styles of the 19th and 20th centuries.

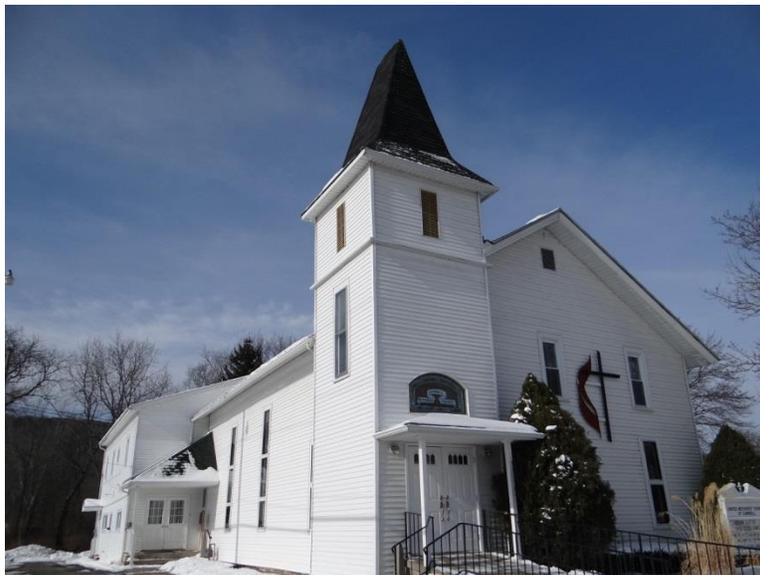
This religious building has faint elements of the Queen Anne style detailing. The building is clad in vinyl siding and retains a stained-glass window above the front entrance double doors. The entrance leads into the first-story of the southeast tower. Front façade windows are one-over-one, double-hung. A large two-story addition is at the rear of the building. All roofs are covered with asphalt shingles.

This church is historically significant religious building constructed ca. 1833. The building was originally located along the Cohocton River, but was moved in the mid-1800s into town by use of horse and logs. The church is currently not eligible for listing, but if the vinyl siding were removed, the historic wood siding could be found beneath and qualify for possible National Register listing.

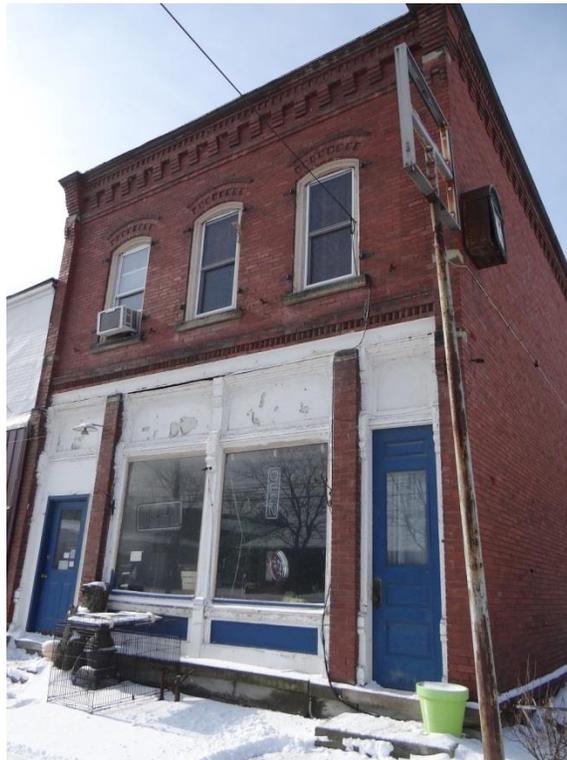
This is a two-story, three-bay, Italianate-style commercial building. The front façade retains the original cast iron storefront and brick columns. The southeast door on the front façade is a replacement and the transoms above the storefront have been painted. An original half-lite, two-panel wood door remains at the northwest end of the storefront. A decorative turned dentil brick band spans the width of the building just above the storefront. The second-story features three one-over-one windows set into the original openings. These windows each have a simple stone sill and vertical arched brick lintel. The cornice of the building has decorative stepped brickwork. An commercial-style addition is at the southeast side of the building, which was constructed for a previous car dealership.

This building is historically significant as an intact example of a late 19th century brick commercial building with Italianate features and also retains the wood storefront. The building was used as a bank, the Campbell Herald, and Scudder Motors. An historic bank vault, from prior to the 1895 fire, remains on the interior.

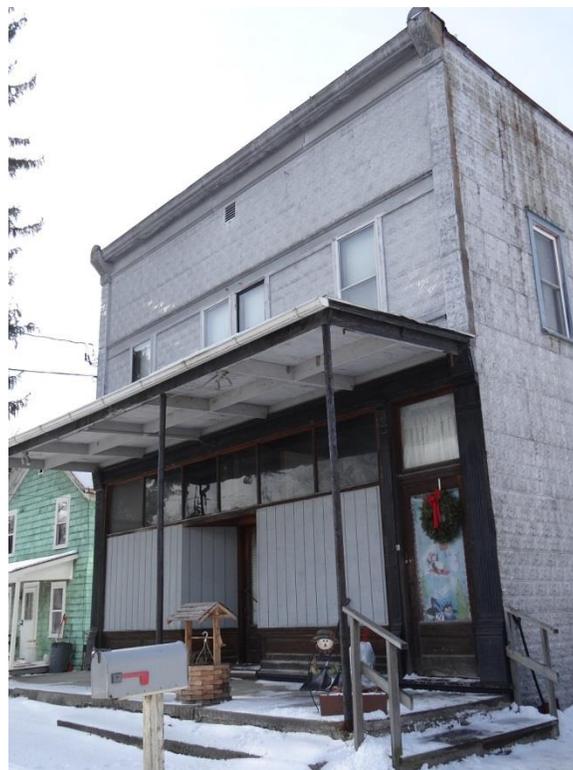
This building is historically significant as an intact example of 19th century commercial architecture. The building retains the original cast iron storefront and metal panel cladding made to look like stone, both of which are seen in an historic photo after it was constructed.

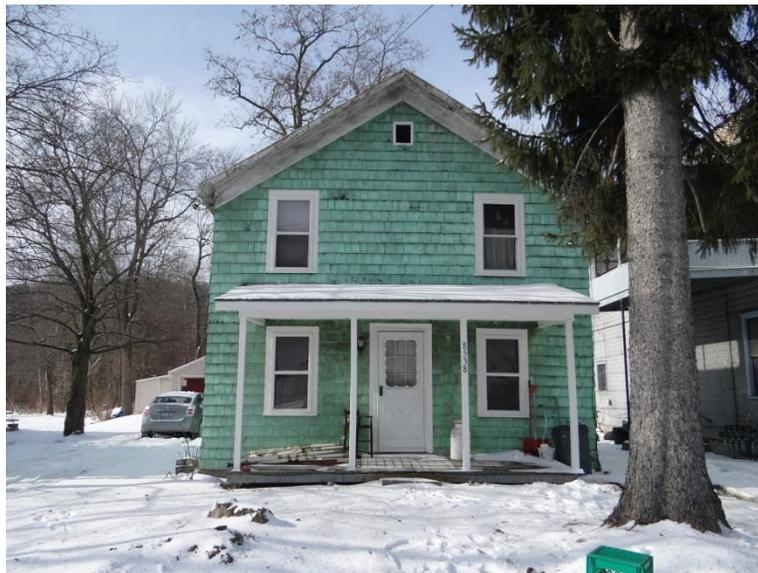
This is a two-story, two-bay, National-style residence with a front-gable roof and subtle hints of Greek Revival detail. The home is clad with wood shingles with one-over-one replacement windows. The entrance is centered on the first-story of the front façade. A one-story porch, which spans almost the full width of the façade, features simple square support posts, a shed roof, and tongue-and-groove wood decking. A small vent opening is centered in the gable of the façade and wide wood trim follows the shape of the gable.

This home is historically significant as an intact example of the National style within the Village of Campbell. The home retains its simple shingle cladding and trims details typical of the architectural style. Overall, the home is significant to the Village of Campbell's intact historic inventory or varying architectural styles of the 19th and 20th centuries.

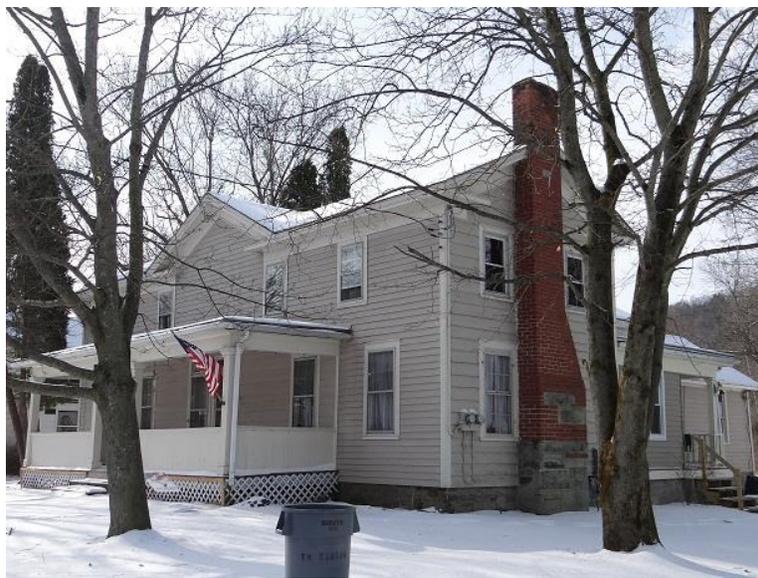
This is a two-story, five-bay, National-style residence with a mainly side-gable roof. At the center of the home, a front-gable roof lines up with the façade, creating a centered pediment above the second-story. The home is clad in wood clapboard siding. A one-story wing protrudes from the rear of the home. The one-story porch spans the center three bays of the front façade and retains the historic tongue-and-groove wood decking and square Doric-style support columns. Just below the eaves is a wide frieze trim. Replacement windows are one-over-one, double-hung, while some remaining historic windows are four-over-four, double-hung. All windows are surrounded with historic trim. A brick chimney rises at the northwest elevation. Originally a single-family home, the building is now a multi-family dwelling.

This home is significant as an intact example of the National style in the Village of Campbell. The home retains historic wood cladding and some historic wood windows. Overall, the home is significant to the Village of Campbell's intact historic inventory or varying architectural styles of the 19th and 20th centuries.

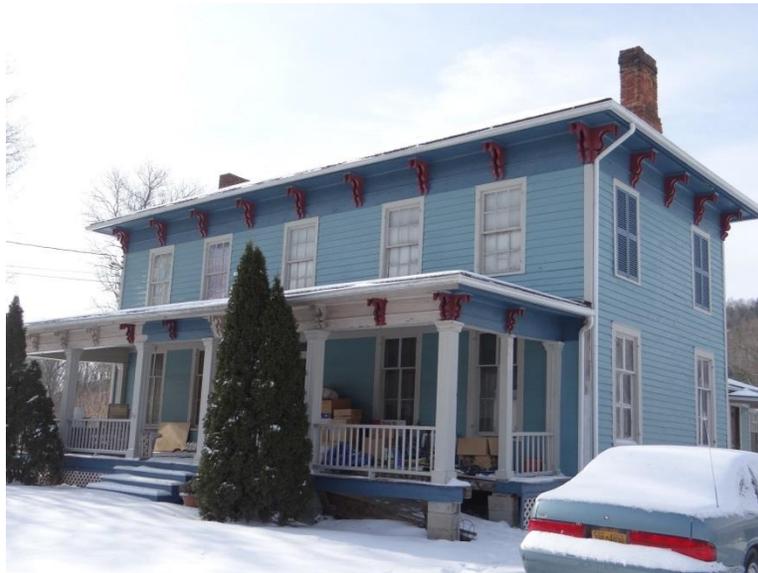
This home is historically significant as an intact example of 19th century Italianate residential architecture. The home retains the majority of original materials, such as the wood clapboard siding, wood windows, eave brackets, and porch. This was home to the Bemis family, who were the only democrats in town. Eleanor Roosevelt also stayed here during a trip to campaign for F.D.R.'s presidential race. Overall, the home is significant to the Village of Campbell's intact historic inventory or varying architectural styles of the 19th and 20th centuries.

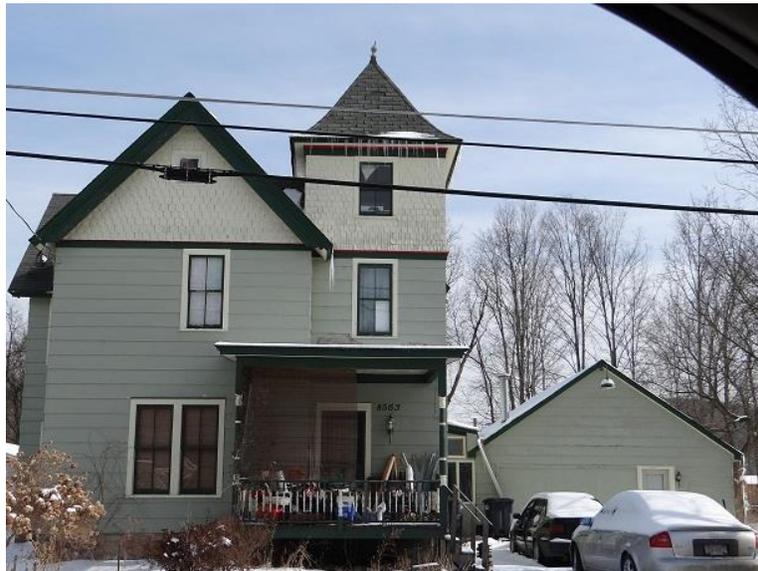
This home is historically significant as an intact example of the Queen Anne architectural style within the Village of Campbell. The home retains a majority of original materials; including wood clapboard siding, wood shingles, wood windows, and porch. Overall, the home is significant to the Village of Campbell's intact historic inventory or varying architectural styles of the 19th and 20th centuries.

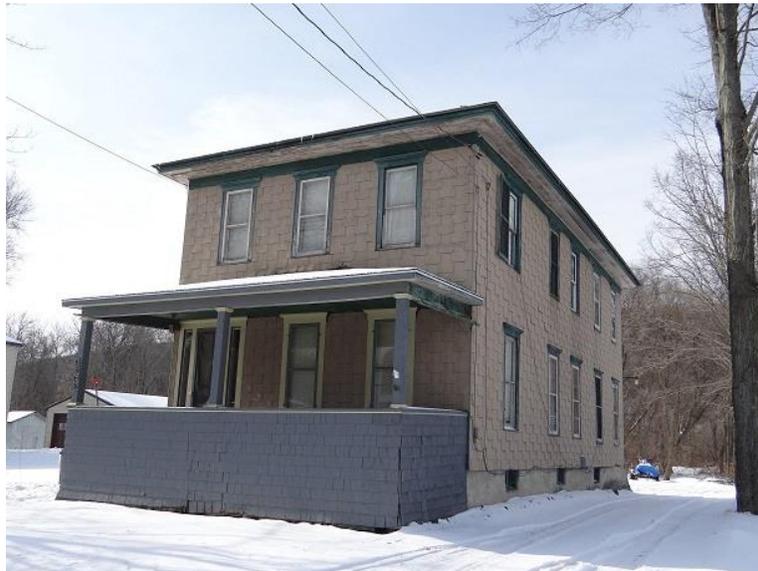
This home is historically significant as an intact example of the Italianate residential style within the Village of Campbell. Although it has been clad in asbestos shingles, the original cladding is likely beneath. Many of the historic wood windows also remain and decorative window and door trim. Overall, the home is significant to the Village of Campbell's intact historic inventory or varying architectural styles of the 19th and 20th centuries.

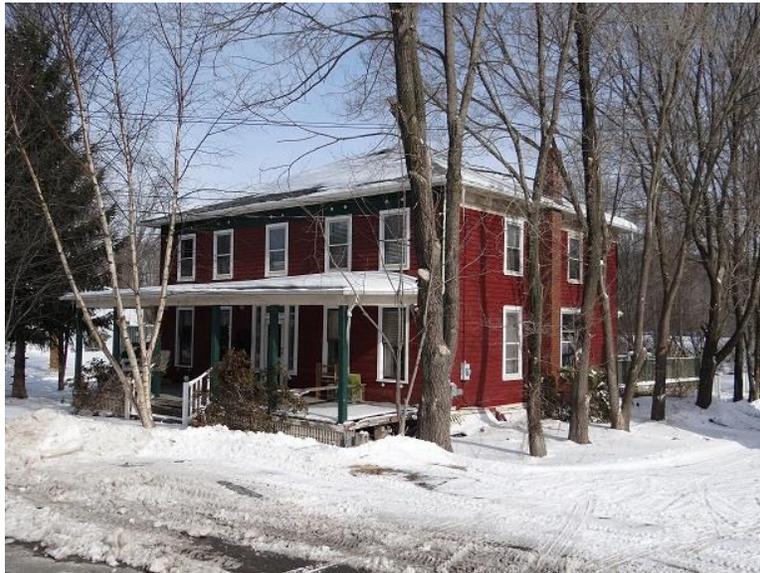
This home is historically significant as an intact example of National style residential architecture within the Village of Campbell. The home retains a majority of the original materials, such as wood clapboard siding and simple decorative trim. Overall, the home is significant to the Village of Campbell's intact historic inventory or varying architectural styles of the 19th and 20th centuries.

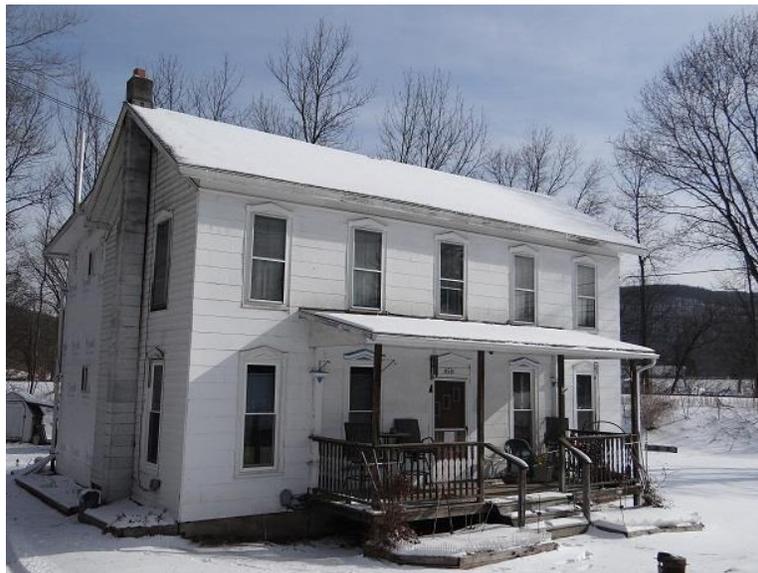
This home is historically significant as an intact example of the National architectural style within the Village of Campbell. Originally, this building was constructed as a railroad store and later converted into a home. Overall, the home is significant to the Village of Campbell's intact historic inventory or varying architectural styles of the 19th and 20th centuries.

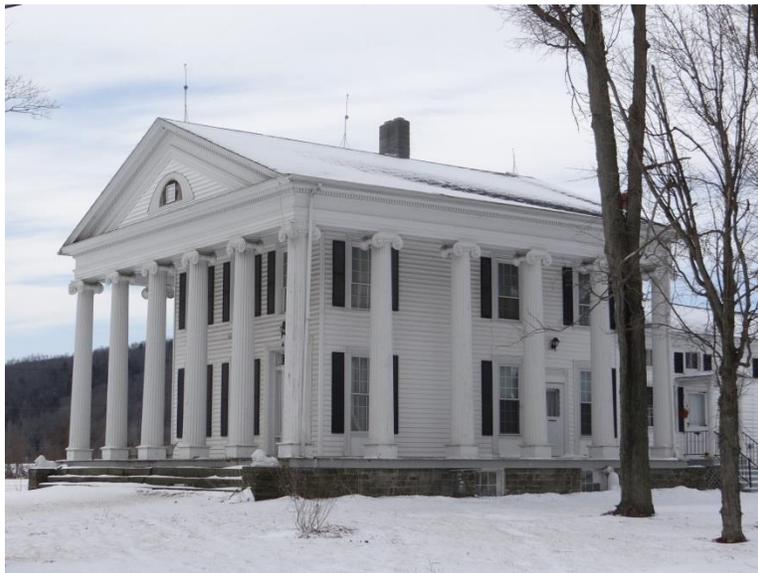
This is a two-story, three-bay, Greek Revival-style residence with a front-gable roof. The home is clad in wood clapboard siding. The roof extends past the house on three side with round, fluted columns with iconic capitals supporting the overhang. Historic tongue-and-groove wood porch decking wraps the three sides of the home over a stone foundation. Three stone steps span the width of the front façade. A decorative cornice detail wraps the house with an architrave, frieze, dentil molding, and cornice. This detail repeats in the gable that extends over the front porch. At the center of the gable pediment is a fanlight openings with a vent installed. Windows are twelve-over-twelve, double-hung and retain the historic decorative trim and rosettes. A parged chimney rises from the center of the home.

This home is historically significant as an intact example of the Greek Revival style. The home was built between 1839 and 1841 by skilled local carpenters who worked from published builder's manuals of the time. Much of the wood portions of the home, such as the columns and window blinds were made from local wood in Bath, NY. The stone was quarried in Addison, NY and the marble found throughout the home came from New York City and had been imported from Europe, most likely Italy. Benjamin Balcom was the father of Uri Balcom, who also owned a large prominent home in town. Overall, the home is significant to the Town of Campbell's intact historic inventory.

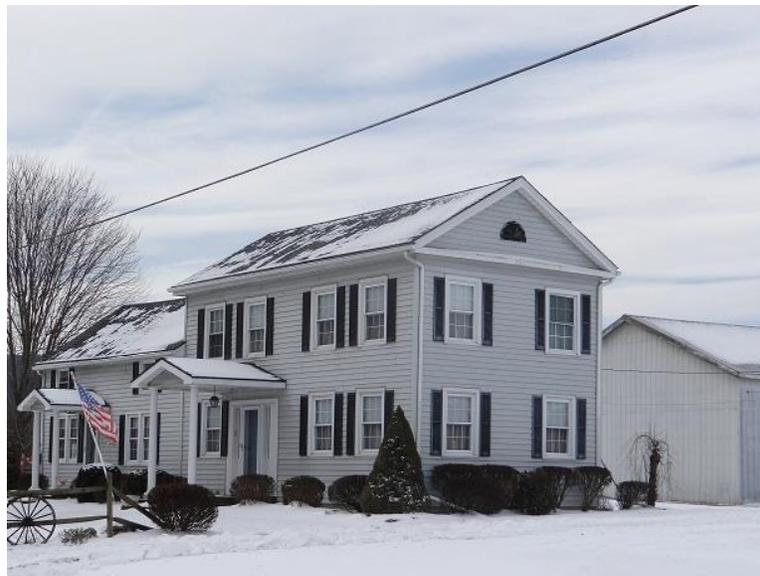
This home is historically significant as an intact example of the Federal style. The home is located on its original property, but was moved slightly from the original location. A property that had been abandoned for some time, the Drumm family purchased the property and conducted a full restoration / renovation of the home. Although the exterior of the home is now clad in modern vinyl materials, it is likely that the historic materials are beneath. Overall, this home is significant to the Town of Campbell's intact historic inventory.

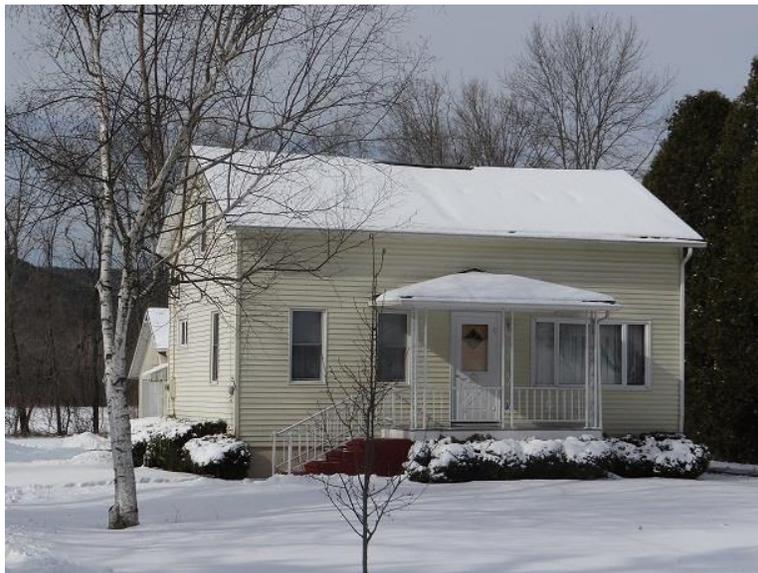
This home is historically significant as an intact example mid-1800s architecture in the Town of Campbell. The home was originally constructed as the second school of the western portion of Campbell and pre-dates 1843. The building was later converted to a residence. Although there have been modifications during the transition into a home, this home could be an important component to the historic inventory around Campbell with work to restore more of the historic characteristic and features.

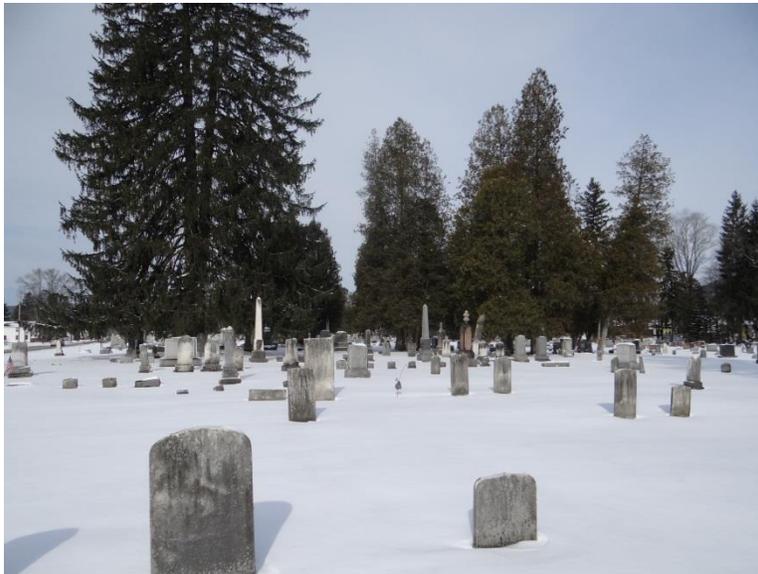
This cemetery is historically significant as an important site within the Town of Campbell. The Rev. Robert Campbell, for whom the town is named, first constructed his home on the land near where the current cemetery lays. His son, Bradford, died in 1805 and was buried on the family's property, which later became part of what is now Hope Cemetery, making him the first person buried here. The last surviving member of the Campbell family, Robert Campbell's daughter Lucy, was also buried in the cemetery. There are also six War of 1812 soldiers and forty-six Civil War soldiers buried at Hope Cemetery.

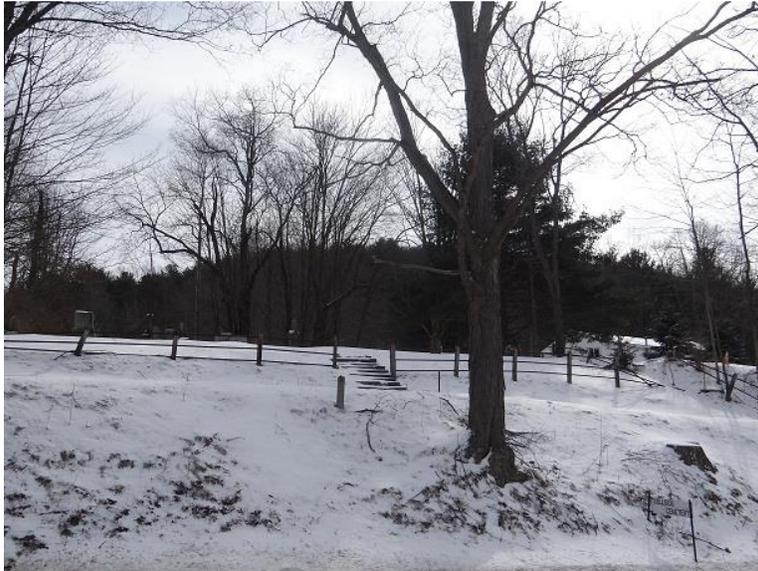
This cemetery is historically significant as an important site within the Town of Campbell. The cemetery was formed early on in Campbell's history and has many old headstones. There is one Revolutionary, six Civil War, and one Spanish-American War, and several War of 1812 soldiers buried in this cemetery, which add to the significance of this site. The monument of Solomon Campbell, Rev. Robert Campbell's nephew who moved to the area with him, is also still standing. Many of the early settlers were buried in this cemetery, including Daniel Horton, Joseph Stevens, and Archa Campbell.

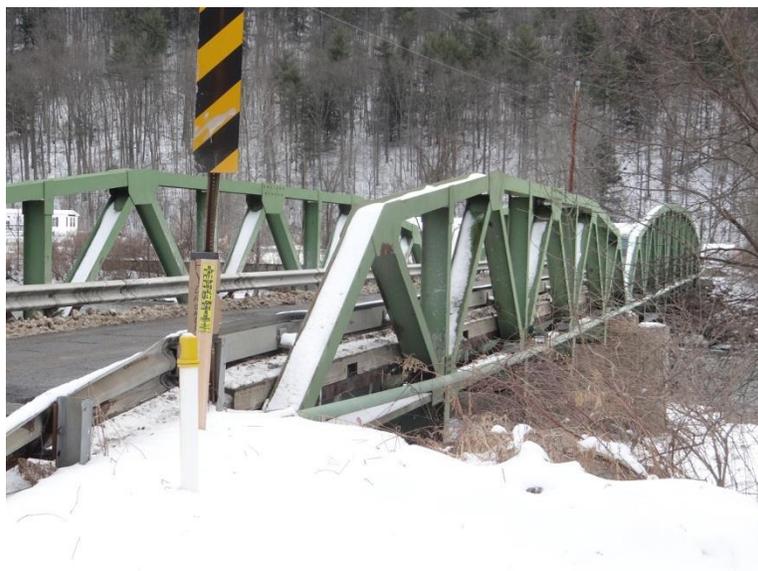
This bridge is historically significant as an intact structure within the Town of Campbell and is thought to be the first bridge in the area to cross the Cohocton River. The original wood constructed bridge remains beneath the steel and asphalt structure that was built to carry the load of modern vehicles.

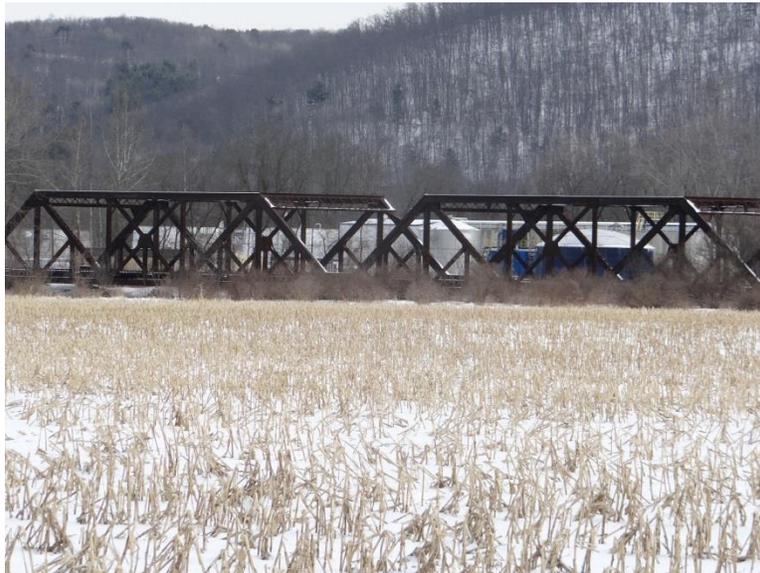
This bridge is historically significant as an intact structure within the Town of Campbell. The bridge was constructed so that rail traffic could manage the winding Cohocton River, allowing for straighter track laying. The bridge is constructed of wood and steel and has remained in use since its erection.
